INDEX OF TEXAS ARCHAEOLOGY

Investigation and Recovery of USS Westfield (Site 41GV151) Galveston Bay, Galveston County, Texas

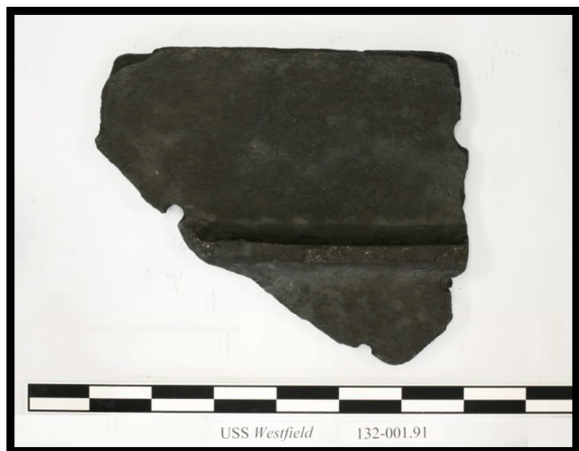
FIGURE 101. FRAGMENT OF BASEPLATE (ARTIFACT
132-001.91; SCALE DM)

Several fragments of *Westfield's* cylinder and condenser assembly have been identified, of which four are of considerable size (Figure 96). All of these fragments have a curvature consistent with a diameter of 50 inches, matching the historical record. Most engine cylinders had a wall thickness of 1 to 1.5 inches but also incorporated stiffening rings spaced evenly along the cylinder assembly as a method of reinforcement (Whittier 1983:15). *Westfield's* cylinder and condenser artifacts are 1 inch thick and many exhibit stiffening rings measuring 5 inches high and 0.5 inches thick (in addition to the wall thickness). All four of the larger curved fragments can be identified as coming from the lower condenser. Although heavily weathered, Artifact 132-016 still contains a broken remnant of the dividing plate that separated the condenser from the upper cylinder (Figure 97). Two of the artifacts (132-006 and 138-001), are still bolted to the base plate that formed the condenser's foundation (figures 98 and 99). In order to secure the engine cylinder and condenser together to the lower base plate, the ends of each cylindrical component contain a 1-inch-thick lip, 4 inches wide. On this lip, fastening bolts are spaced 6.5 inches apart. In total, four base plate fragments were recovered (132-001.91, 132-006, 138-001, and 140-004). These plates are 1.75 inches thick. During initial de-concretion efforts, conservators noticed that all of these plates retained wooden splinters on their undersides from the massive bed frame timbers that formed the foundation of the entire engine. Amazingly, Artifacts 132-006 and 138-001, along with Artifact 134-007 (no base plate) still fit together and can be rejoined along their fracture points (Figure 100). Based on the rejoining of these artifacts and the known orientation of *Westfield's* engine (condenser/engine cylinder aft, air pump/hot well forward), conservators were able to determine that these three artifact came from the starboard side of the vessel. Following the bolt pattern on these joined artifacts, base plate Artifact 132-001.91, which could not be rejoined, came from *Westfield's* port side (Figure 101).

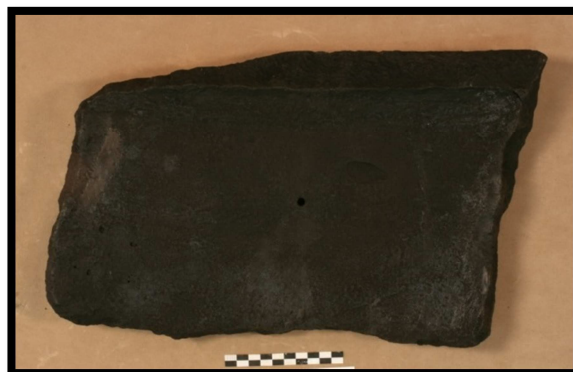
FIGURE 103. ROUNDED FRAGMENT FROM REAR
CHANNEL WAY WALL (ARTIFACT 133-004)

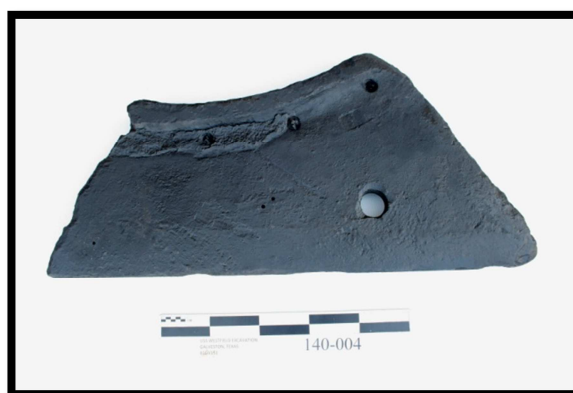
FIGURE 104. UNDERSIDE OF AIR PUMP BASE PLATE
WITH NARROWING CHANNEL WAY WALL (ARTIFACT
140-004; SCALE CM)

Beneath the base plate fragments, portions of the "channel way" leading to the air pump survived. The largest channel fragment, found on Artifact 138-001 (Figure 102), although incomplete, indicates that the port and starboard sides of the channel way were relatively flat and the chamber had a depth of at least 1 ft. Numerous fragments from the channel way walls survived independently. These fragments, combined with the portions that remained attached to the base plates, allowed conservators to determine that the original shape of the channel way was designed to facilitate the forward movement of water. One smaller fragment came from the aft portion of the channel way (Artifact 133-004). This fragment shows that the shape of the condenser continued down into the channel way creating a rounded aft wall (Figure 103). The largest recovered base plate fragment (Artifact 140-004) supported the air pump/hot well cylinder assembly. A surviving section of the inner ring on the base plate has a diameter of 42 inches. Remnants of the channel way show that its walls slightly narrow in the forward direction to accommodate the smaller diameter of the air pump cylinder (Figure 104). Artifact 140-004 is from the starboard side of the channel way.

through rounded holes in the base plate as seen in figures 99 and 104. Each hole had a diameter of 2 to 2.25 inches. Cast iron washers lay between the square nut and the plate surface (Figure 109). The washers acted as a sacrificial surface that could rotate if needed and spread the load placed on the bolt heads (Jim Jobling, personal communication 2014). A variant of this bolt type was also recovered (Artifact 132-001.92). Rather than containing a smaller square nut and an underlying washer, this bolt instead utilized a single larger wrought iron nut that accomplished both tasks (Figure 110).

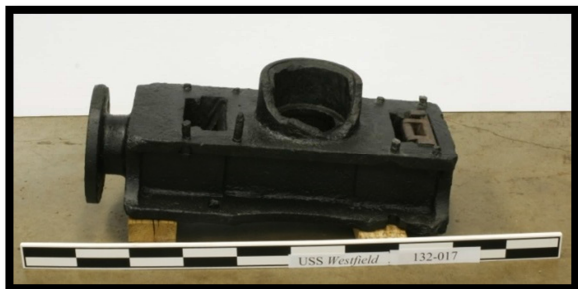
FIGURE 105. VALVE ASSEMBLY FROM AIR PUMP/HOT WELL RESERVOIR (ARTIFACT 132-017; SCALE DM)

No historical information has been found regarding the construction of *Westfield's* air pump and hot well. Fortunately, in addition to the lower base plate fragment (Artifact 140-004), a large artifact from the air pump was recovered remarkably intact (Artifact 132-017). This artifact is one of two valve assemblies that received water from the upper hot well reservoir as a means to refuel the boilers' water level (Figure 105). Like the base plate fragment, the recovered valve assembly came from the starboard side of the engine assembly. This placement is evident due to the forward flowing direction of the interior valves. The artifact measures 2 ft long, 10 inches wide, and 6 inches tall. The pipe that led to the forward boilers has a diameter of 4 inches and an attachment flange with a diameter of 9 inches. The feed pipe that led down from the hot well reservoir is broken but can be reconstructed with a diameter of 7.75 inches. After removing protective cover plates and broken pipe flanges, conservators recovered all of the original sealing gaskets (Figure 106). Inside the artifact, two brass valves are held in place by brass wedges, all of which are seated in lead (Figure 107).

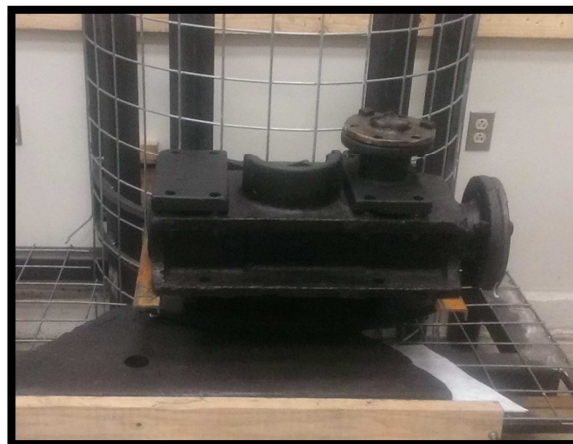
FIGURE 108. RECONSTRUCTED VALVE ASSEMBLY AND LOWER BASE PLATE FRAGMENT (ARTIFACTS 132-017 AND 140-004)

Originally, this artifact was mounted outside the air pump cylinder on a shelf, directly beneath the hot well reservoir (Figure 108). Both the shelf and a large fragment of the air pump cylinder survived with the valve assembly. The shelf measured 1 ft 4 inches wide and 6 inches tall from the base plate. The air pump cylinder fragment indicates an internal diameter of 40 inches that fit into the curved portion of the base plate (Artifact 140-004), and like the condenser/engine cylinder, was mounted with a reinforced supporting flange that bolted down over the plate. Unfortunately, the exact heights of the air pump and the hot well can only be speculated. On most walking beam engines, this dual assembly generally reached just slightly taller than both the condenser and the engine cylinder's lower piston stop. Applying this generality to *Westfield*, the height would have measured approximately 6 feet tall. Based on other walking beam engines, the air pump cylinder, if completed, once contained a rounded flange at the top with a rim that stood just inside the edge. This flange was utilized as a lower base plate for the hot well reservoir cover. During construction, the cover would have been lowered down and seated onto this plate. The rim on the plate sat inside the cover, preventing the cover from sliding off. One fragment from this plate and rim survived (Artifact 132-001.57). The rim on this fragment sits 1.5 inches inward from the ledge, indicating that the cover contained a general thickness of 1 inch, plus a 0.5 inch stiffening ring at the bottom. Based on the curvature, the rim on the plate had an inside diameter of 5 ft 2 inches. Adding the thickness of the missing cover (not accounting for the stiffening rim), the hot well reservoir had an inside diameter of 5 ft 4 inches.

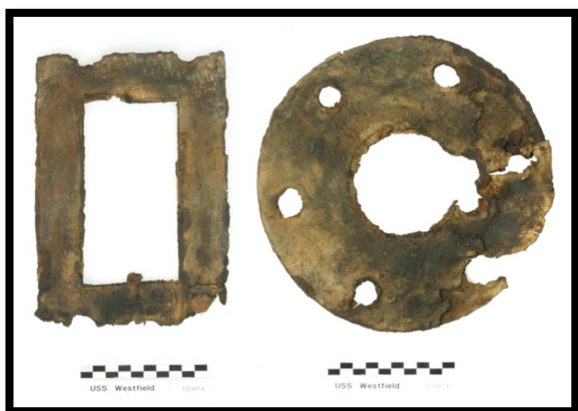
FIGURE 106. EXAMPLES OF INTACT GASKETS FROM VALVE ASSEMBLY (ARTIFACT 132-017.6 AND 132-017.8)

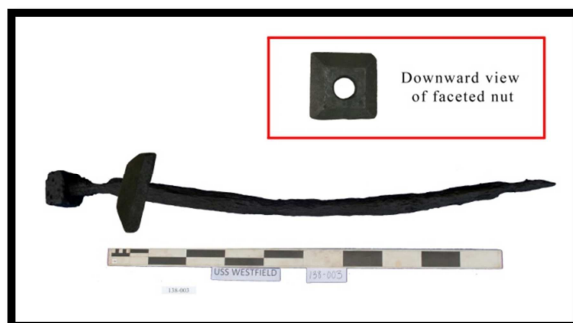
FIGURE 109. TYPE 1 MASSIVE BOLT AND WASHER FASTENER FOR CYLINDER BASE/BED FRAME TIMBERS (ARTIFACT 138-003; SCALE CM/DM)

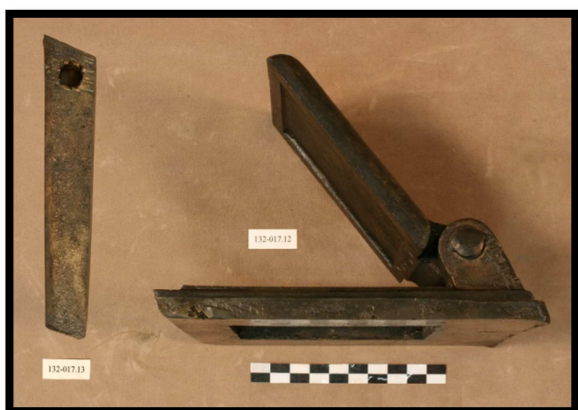
FIGURE 107. BRASS VALVE AND WEDGE FROM VALVE ASSEMBLY (ARTIFACTS 132-017.12 AND 132-017.13)

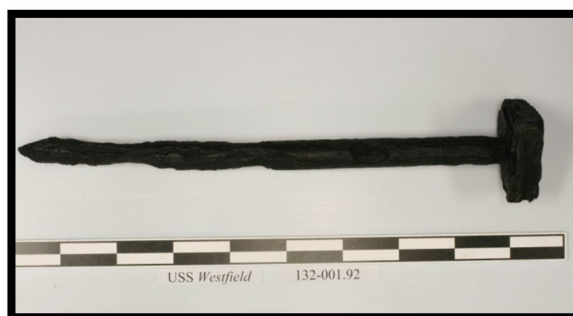
FIGURE 110. TYPE 2 MASSIVE BOLT FASTENER FOR CYLINDER BASE/BED FRAME TIMBERS (ARTIFACT 132-001.92; SCALE DM)

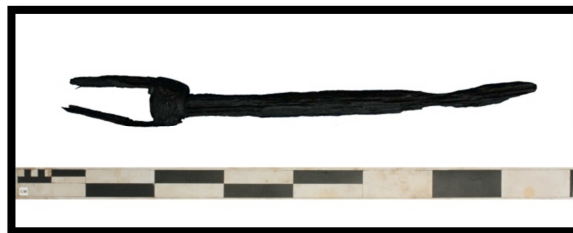
FIGURE 113. SMALLER TURNBUCKLE FROM SMOKE STACK (ARTIFACT 133-034; SCALE CM/DM)

Excavations recovered two wrought iron turn buckles of which one was smaller and the other heavily constructed. The smaller of these turn buckles measures about 3 inches wide across the buckle (Artifact 133-034). Due to the smaller size, this artifact may have supported *Westfield's* smoke stack rather than the engine (Figure 113). The A-frame required substantial reinforced rods and turnbuckles to counteract the forces of the constantly moving engine. The larger turn buckle (Artifact 117-002) measured 1 ft 8 inches long, 6 inches wide, and 2 inches thick. Attached to each end of the buckle, several feet of the securing rod survived (Figure 114). Like the stub on the bearing block shackle, the rod has a diameter of 1 inch. Numerous other wrought iron rod fragments were recovered. All of these artifacts contained hexagonal nuts that were threaded onto the rods. Interestingly, some of the threads on these wrought iron rods are brass. Artifact 133-053 contains a heavily eroded nut that allows parts of the brass threading to be inspected (Figure 115). This brass bushing prevented the nut and bolt from rusting together, therefore allowing tightening or loosening as needed.

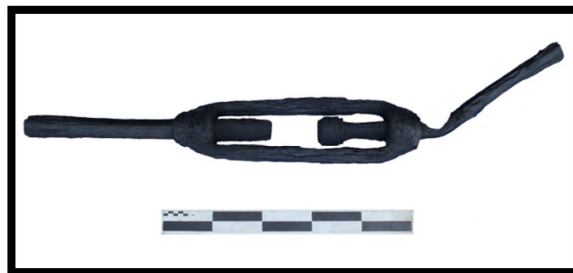
FIGURE 114. LARGE TURN BUCKLE FROM A-FRAME (ARTIFACT 117-002; SCALE CM/DM)

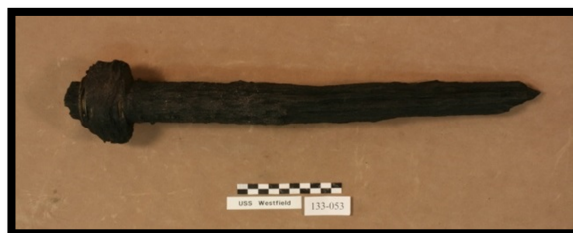
FIGURE 115. ROD ARTIFACT WITH THREADED BRASS BUSHING (ARTIFACT 133-053)

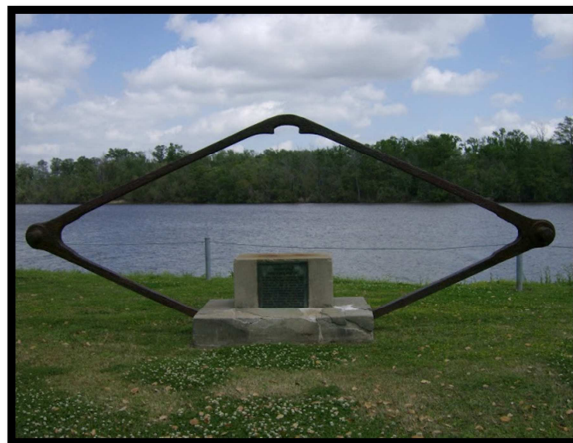
FIGURE 116. WALKING BEAM FROM *USS CLIFTON* AT RIVERFRONT PARK, BEAUMONT, TEXAS (UNKNOWN PHOTOGRAPHER)

Like *Westfield*, *Clifton* sank in Texas during the Civil War. Salvage operations recovered *Clifton*'s walking beam during the early 20th century (Figure 116). In 2012, this artifact underwent conservation at the CRL. During conservation, measurements recorded from *Clifton*'s walking beam were smaller than those indicated by the Memphis drawing, at 20 ft wide by 9 ft tall. This difference in size may be an issue of artistic interpretation or engine manufacturers. Since the vessels were built at the same time and designed for the same engine, a difference in walking beam size is unlikely. Evidence from an artifact is more reliable than a drawing; therefore, *Westfield*'s reconstruction follows the dimensions of *Clifton*'s walking beam.

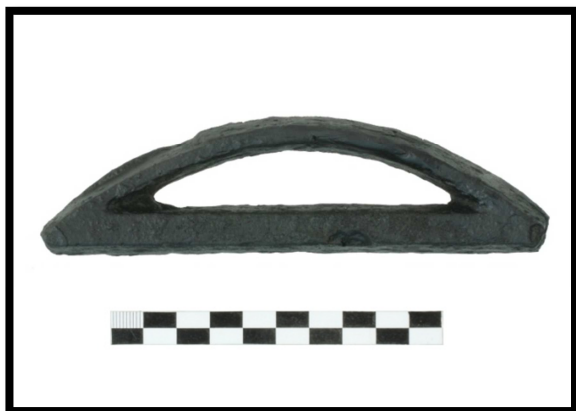
FIGURE 117. UNIDENTIFIED MOON-SHAPED MACHINERY COMPONENT (ARTIFACT 40)

Just south of the firebox on what would have been *Westfield's* starboard side, recovery efforts found a unique object (Artifact 40) shaped like a quarter moon with a larger flat edge (Figure 117). The poor state of the metal was beyond saving, yet conservators successfully made a mold and resin copy of the original to allow for study. This artifact was made of cast iron and contained a unique curve along the length. The curve prevented the object from lying flat. On the rounded edge, an indentation was molded at the time the artifact was manufactured. This indentation may have allowed the artifact to be easily removed from another object. How this artifact was used remains unclear.

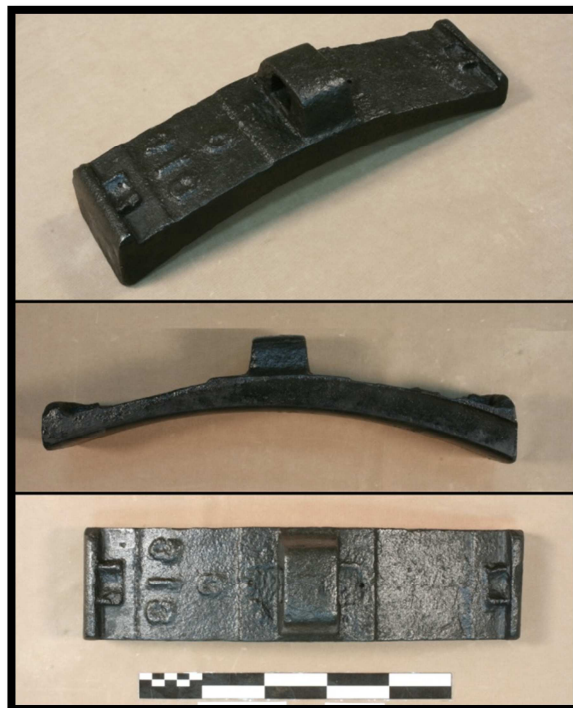
FIGURE 119. UNIDENTIFIED MACHINERY COMPONENT WITH EMBOSSED "313" (ARTIFACT 129-002)

Artifact 129-002 is an unidentified cast iron machinery piece that has many diagnostic features (Figure 119). In general appearance, the artifact looks like a rounded pad that fit over another curved object. The other missing object clearly rotated and over time wore down the artifact's lower surface and one of the sides. All of the wear marks are radial and very smooth. However, the wear pattern is uneven, suggesting that the artifact may have been out of calibration with the other piece of machinery. Looking at the artifact from either side, the artifact originally appeared to have identical ends. Now one end is quite thinner than the other. The top of the artifact contains the embossed numbers "313" and "0". There are also several curved mounting points on the top ends, as well as a raised opening at the top center. These features imply that another object slid through the opening and lay down into the mounting points. Despite that numerous components on walking beam engines rotated, there does not seem to be any equivalent to this artifact on existing plans. How this artifact was used, and to what piece of machinery it belonged, remains unclear.

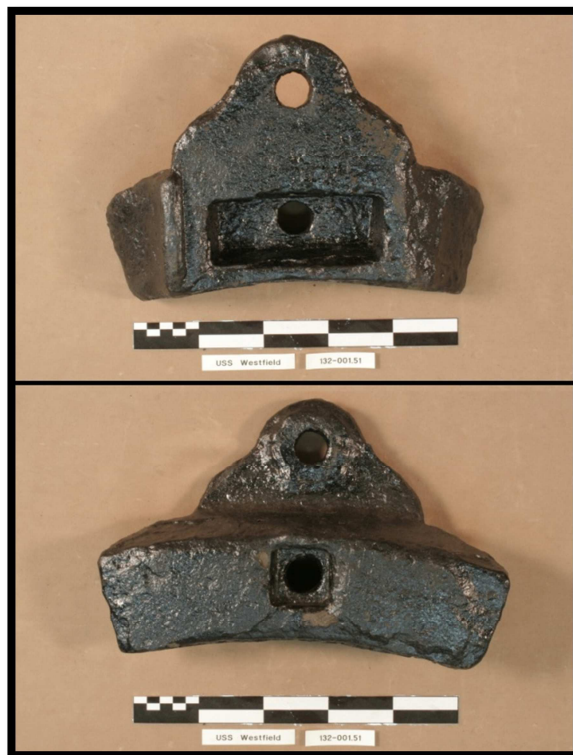
FIGURE 120. UNIDENTIFIED CAST IRON PEDESTAL-LIKE OBJECT (ARTIFACT 132-001.51)

One of the first artifacts conserved by CRL was a pedestal-like artifact made of cast iron (Artifact 132-001-51). The main body of the artifact is heavily constructed, rounded on two sides, and contains a central mounting hole for a recessed square headed bolt (Figure 120). On the bottom side of the object, two projecting ridges indicate that the artifact sat on another object that likely contained dual recesses to receive the artifact. The ridges on the artifact likely sat within those recesses to prevent sliding, and the upper recessed bolt secured both objects together. Based on tiny fragments of wood recovered from the recessed bolt hole, conservators believe the other object was made of wood. Branching off from the wider rounded side of the artifact, a unique rim shape contains a reinforced mounting hole for another unknown object. How this object was used is unclear, but the heavy construction and reinforced features indicate it may have been a part utilized in machinery.

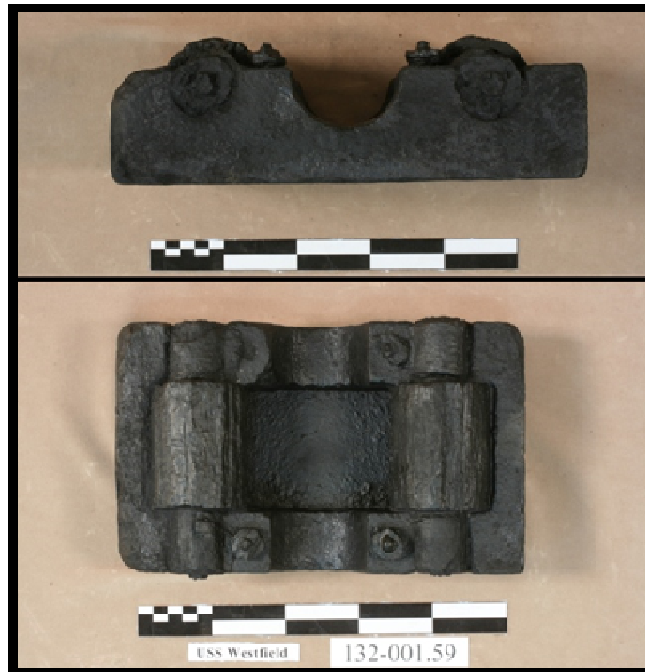
FIGURE 121. UNIDENTIFIED SMALL BEARING BLOCK
(ARTIFACT 132-001.59)

Artifact 132-001.59 contains many features to suggest the object may have been a three part bearing block for a larger piece of machinery (Figure 121). The artifact appears to be the lower base for an object consisting of two components. Four hexagonal bolts near the center likely joined the artifact to the now missing top portion. The interior is hollowed out in a rectangle that follows the shape of the exterior. Across the hollowed out center, there are three semi-circles on each outside

wall. If this object was a bearing block, then the missing upper section likely also contained these semi-circles to secure the objects that the artifact intended to bear. The outer semi-circles are smaller and both still retain axel-like objects and rollers that are now fused to the main artifact. Both of these axels and their associated rollers are wrought iron. The center larger semi-circles are open, indicating that the object they supported is now lost. The surviving axels and rollers may have assisted in rotating a belt of some sort through the machinery. Without more of the original machinery to which this artifact belonged, the exact function remains speculative.

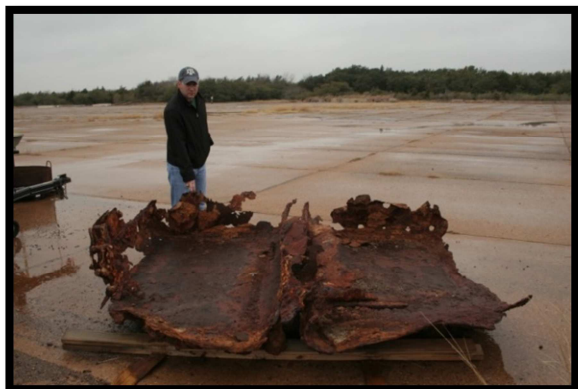
FIGURE 123. REMAINS OF LOWER FIREBOX
(ARTIFACT 132-001)

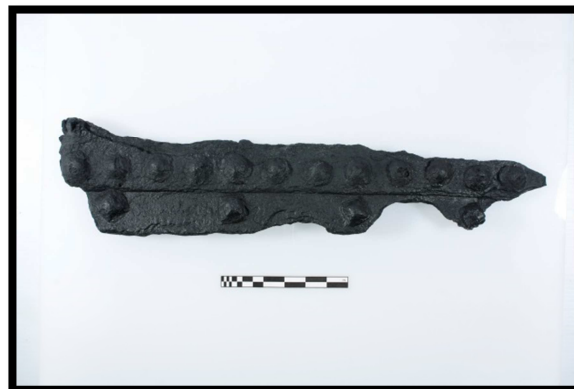
FIGURE 126. RIVETED PLATE FROM STEAM DRUM
(ARTIFACT NP-50; SCALE INCHES)

The section of riveted plating clarifies how the two boilers were originally joined together. Unlike other recovered boilerplates, this small fragment (Artifact NP-50) contained not only a folded riveted seam, but a reinforced underlying plate secured by square-headed bolts (Figure 126). An example of this plate can be found on an image of *Clifton*'s upper steam drum, photographed over 70 years after the vessel's sinking (highlighted in Figure 127). This image offers considerable information about how the boilers were constructed. Following manufacture, the boilers would have required individual lowering and placement into *Clifton*'s hull. Based on this image, each boiler contained half of a shared upper chimney flue. The flue fed up and out of the vessel's central machinery compartment, before connecting to the smoke stack. The two portions of the flue were joined together along a central seam, reinforced on both sides by square-headed bolts.

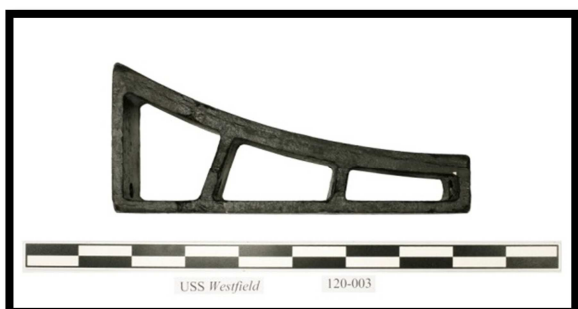
FIGURE 124. BOILER MOUNT (ARTIFACT 120-003;
SCALE DM)

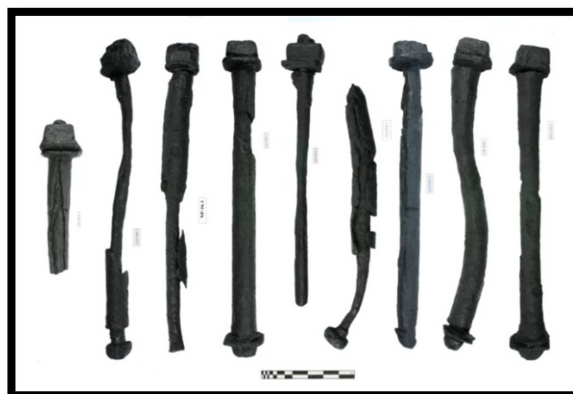
FIGURE 128. MASSIVE STAYBOLTS FROM UPPER
STEAM DRUM (SCALE INCHES)

Numerous large staybolts from *Westfield's* wreck site indicate that the vessel utilized this type of steam drum (Figure 128). On the *Clifton* image, rather than completely encircling the flue, the plates of the steam drum abruptly curve inward, and are securely riveted down before reaching the reinforced central seam. This indicates that each boiler utilized a separate steam drum compartment. While the other side of the drum cannot be seen within the image, the arrangement was likely identical to the one found on the front. This would have created two distinct semi-circular steam compartments.

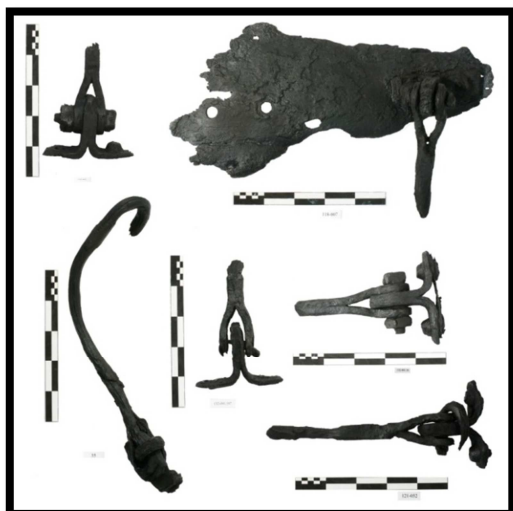
FIGURE 131. CROW'S FOOT STAVING DEVICES

The crow's feet came in several variations. The majority are of the single type. These were made out of two pieces of rectangular boiler iron that were bent into a "T" shape. The object was riveted to a surface and then a staying rod with end loops was placed over the device. To secure the rod, a bolt was passed through the loops and the shaft of the "T" (Figure 131). Another type incorporates two longer boiler straps that were folded down on all four ends, creating a double crow's foot in the shape of a handle (Figure 132; Peabody and Miller 1894:92). Several larger plates believed to have come from the lower portion of the chimney flue, utilized a large number of these double crow's feet (Figure 133). These handle-like staying devices received vertical support rods attached to the crowns of the furnaces and the longitudinal supports that ran the length of the boiler. Another example consisted of a double crow's foot, that was shaped like the cross section of an "I" beam. A large number of these supported heavier objects in the boiler.

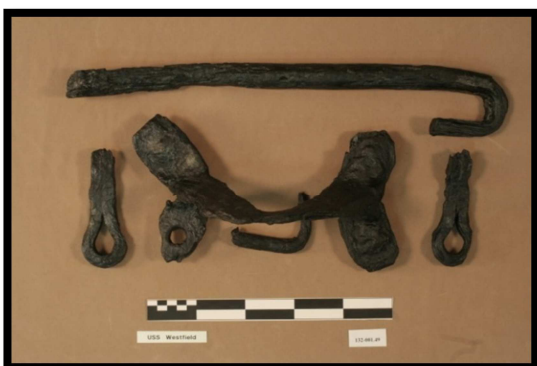
FIGURE 132. DOUBLE CROW'S FOOT, HANDLE-SHAPED WITH HOOKED RECEIVING ROD (ARTIFACT 132-001.49)

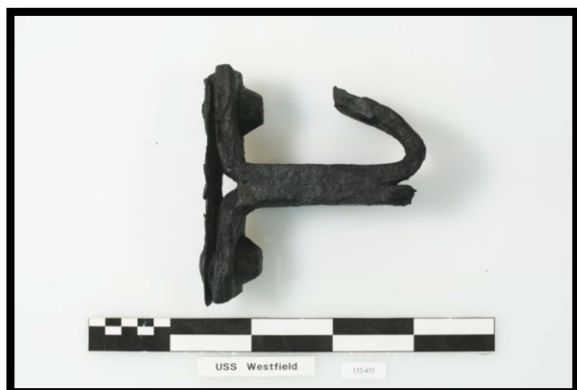
FIGURE 137. DOUBLE-ENDED CROW'S FOOT
FASTENER (ARTIFACT 132-431; SCALE CM)

two on top and two on bottom, to join the outer water jacket to the bottom of the furnaces (Figure 137). The transition to these fasteners was likely necessary to prevent the furnaces from shifting under the weight of the fire grates, which may have happened if the furnaces stood on top of cylindrical staybolts, rather than flat-surfaced brackets.

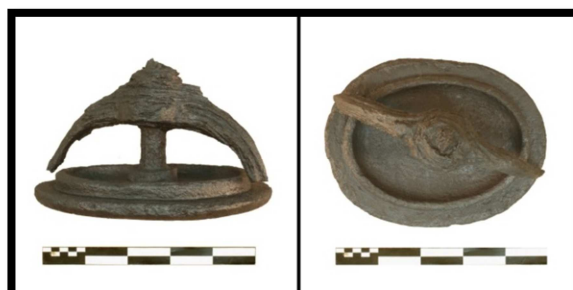
FIGURE 141. LARGER SIZED HAND HOLE CLEANING
COVER (ARTIFACT 120-053; SCALE CM)

To access different parts of the water jacket surrounding the firebox, numerous "hand holes" were placed, that permitted occasional cleaning. Exactly where these hand holes were placed is speculative. Yet as mentioned earlier, convenient placements would have positioned many on the corner edges of the firebox, in between the water legs, and in the spandrels above the furnaces (Figure 138). The plate on the hand hole could be removed when the boiler was not pressurized. This was done by unthreading a nut and removing the securing handle. Three different sizes of hand hole cover were recovered. The smallest measured 6-3/8th inches by 4-3/8th inches. While the cast iron was in relatively good condition, the wrought iron handle did not survive (Figure 139). The middle size measured 7-5/8th inches by 5-5/8th inches. This type used a double-arched handle, which when facing looks like an "X" (Figure 140). The larger size measured 10-1/8th inches by 7-5/8th inches. The handle on this version was singular, consisting of only one arch (Figure 141).

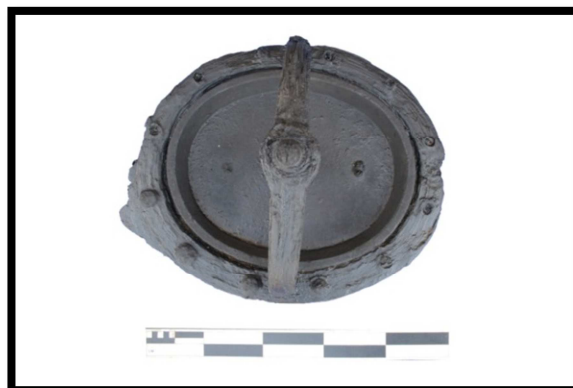
FIGURE 142. MAN HOLE ACCESS HATCH INTO
BOILER (ARTIFACT 122-042; SCALE CM/DM)

A similar, yet much larger version of these artifacts was known as a "man hole." This artifact type permitted physical human access into the boiler's interior. Two of these large artifacts were recovered (Artifacts 119-019 and 122-042). In general appearance, man holes resembled hand holes, but were considerably more reinforced (Figure 142). The back plates measured 14.5 inches by 12 inches. Both of the recovered man hole covers contained a single arched handle. Rather than just relying on the handle to secure the covers in place, the entire back plate was secured against a thick wrought iron lip that was rivet down on the boilerplate. One of these man hole covers (Artifact 119-019) is believed to have come from the rear of the boiler barrel (Figure 143). The artifact still retains a large piece of boiler plating complete with a rounded strap of rivets (Figure 144). A third man hole was indirectly identified. Knowledge of the object's former presence can be found in too cast iron fragments (Artifacts 131-019 and 132-001.56) that once formed the man hole's frame (Figure 145). This missing man hole is also believed to have come from the boiler barrel, specifically on the top. Examining the artifacts, the original shape can be determined as oval. Yet, while the tops of these artifacts remain flat, their bases are arched, indicating that they were mounted to a cylindrical surface. An identical example of this frame can be seen on the boiler plan for the USS *Commodore Barney* (Figure 146).

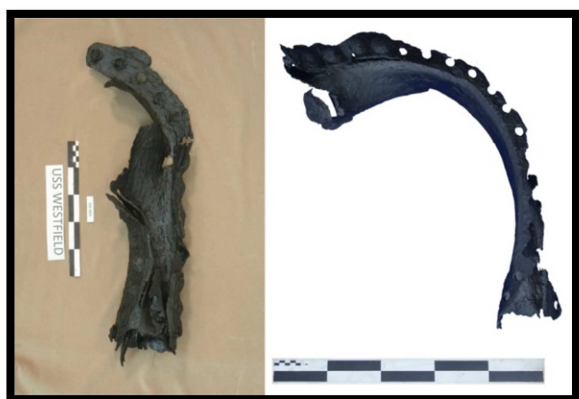
FIGURE 155. TWISTED FRAMES FROM UPPER FIRE DOORS (ARTIFACTS 120-002 AND 120-023; SCALE CM/DM)

120-023). These artifacts follow the curvature of the fire doors, although both are twisted outwards, away from their original mounting points due to an interior explosion (Figure 155).

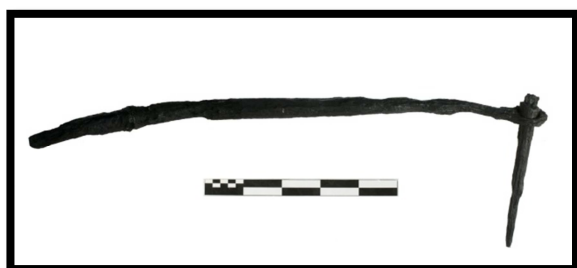
FIGURE 161. FIRE DOOR LEVER AND PIN
(ARTIFACT 125-006; SCALE CM)

When a crew member desired to open the door, he lifted the lever up from a securing cradle fastened to the boiler wall, and then pulled the lever and door open. One of these fire door levers was recovered (Artifact 125-006). The lever consists of an elongated bar with a lifting handle on one end and a pivot ring and inner pin on the other (Figure 161).

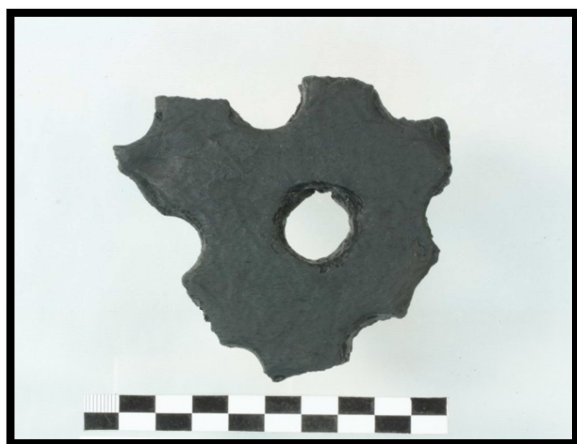
FIGURE 162. CAST IRON FRAGMENT OF BAFFLE
PLATE (ARTIFACT 119-197)

One fragment of a baffle plate was recovered (Artifact 119-197). This small fragment is made of cast iron, and is pierced by numerous holes that facilitated draft (Figure 162). Each of these holes measures $\frac{3}{4}$ inches in diameter. If completed, the baffle plate would have followed the shape of the fire door, but would have been of reduced height and width (Figure 163). This allowed the door to be closed flush against the door frame, while permitting the baffle plate to rest just above the dead plate. A similar example of a baffle plate can be seen on the steamboat *Moyie* (Figure 164). The spacing of the holes and the thickness of the cast iron is almost identical to the fragment recovered from *Westfield*.

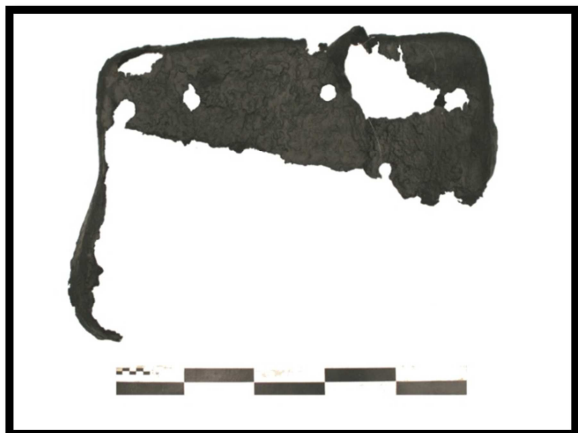
FIGURE 169. FLUE DOOR FROM *WESTFIELD* BOILER
(SCALE CM/DM)

The chimney flue was situated above the fire doors and the inner furnaces. This location marked the termination point for the fire tubes. While no remnants of the fire tubes were found, a single access door for maintaining and cleaning the tubes was recovered (Artifact 109-127). Known as a flue door, this artifact was considerably damaged and twisted (Figure 169). The artifact originally measured approximately 22 inches wide by 16 inches tall. Based on a series of fastener holes, conservators believe this artifact had a similar construction as the fire doors. The surviving portion

of the door represents the outer cover plate. The rear plate and staybolts are missing. Other holes on the plate may indicate where hinges were once placed. Unfortunately, not enough of the plate survives to make any definitive conclusions.

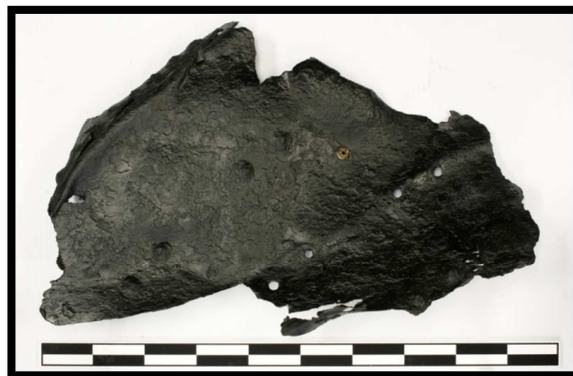
FIGURE 170. PLATE FROM UPPER FIRE BOX COVER
(ARTIFACT 124-032; SCALE DM)

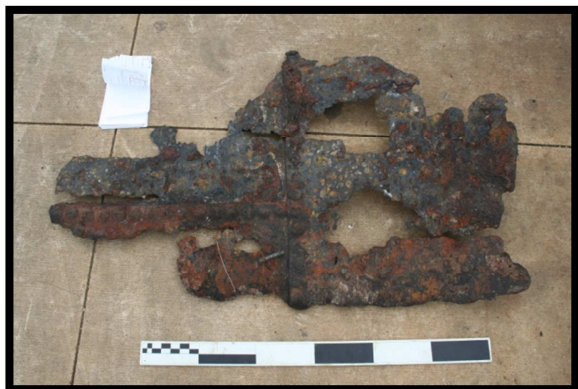
FIGURE 172. LARGE SECTION OF PLATING
FROM OUTER BOILER BARREL
(ARTIFACT 110-005; SCALE CM/DM)

Large flues carried the heated gases, ash, and smoke from the firebox into the boiler barrel. Unlike the firebox, the barrel no longer exists. Yet numerous fragments survived that help explain the original design. Most of the riveted plate recovered from the wreck site is believed to have originated from the boiler barrel, because while most of the plates are deformed they still retain curvature. Two of the best examples can be found in Artifacts 110-005 and 119-001 (figures 172 and 173). One of the most notable features of these artifacts is the absence of internal staying devices. This is not to say that these devices did not exist in the barrel, but only that they were not as necessary and therefore more sparingly used. Unlike the firebox which required heavy staying on the numerous flat surfaces, the round shape of the barrel expanded and contracted with more ease.

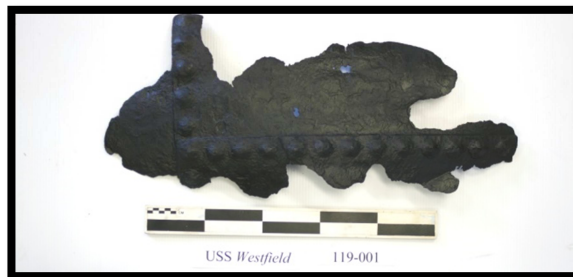
FIGURE 173. SMALL SECTION OF PLATING FROM
OUTER BOILER BARREL
(ARTIFACT 119-001; SCALE CM/DM)

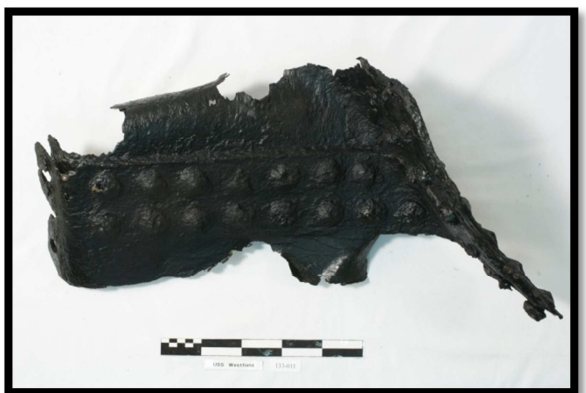
FIGURE 180. LOWER BOILER BARREL CONNECTION PLATES (ARTIFACT 133-011; SCALE CM/DM)

Like the previous artifacts, Artifact 133-011 served as a connection point between the boiler barrel and firebox; however, this object originated from the bottom of the boiler (Figure 180). For this reason, the artifact does not display the eccentric circles. Instead the artifact contains a well preserved, albeit slightly crushed portion of the barrel curve, and a section from the rectangular base of the firebox. The artifact also demonstrates that, in its original context, an additional double-riveted strap branched off from the barrel, before running down the back of firebox and folding underneath.

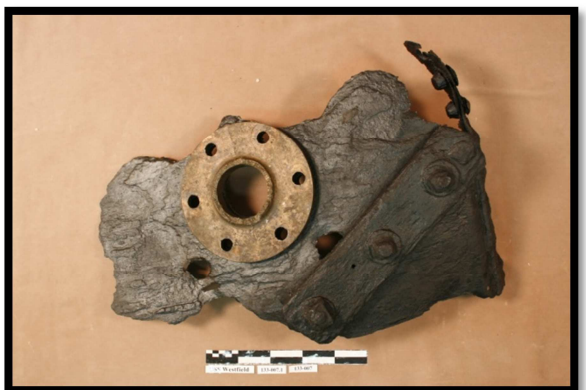
FIGURE 181. REAR FIREBOX FEED WATER PIPE (ARTIFACT 133-007; SCALE CM/DM)

A second artifact came from the same vicinity. Artifact 133-007 was placed slightly higher up on the side of the firebox, yet still below the boiler barrel. The most unique feature consisted of an attached brass pipe flange (Figure 181). Feed pipes leading into the boiler would have been used to refuel the water level. This pipe likely led back to the valve system located beneath the hot well reservoir on the walking beam engine. During conservation, the question arose as to whether this artifact could have come from the front or sides of the boiler, or possibly higher up on the back of the firebox. Several staybolt holes in the metal eliminated any chance that the artifact came from the boiler's front. Staybolts on the front of the boiler would have been on either side of the fire doors. Based on the width of each furnace, this artifact would not have been able to fit without interfering with fire doors. The second evidence comes from the joining of the outer plate with the line of rivets that run up the artifact's side. Based on other recovered artifacts, plates from the front

and rear of the firebox, as well as those from the back of the boiler barrel, always tucked underneath the side plates. Why this was done is not clear, however based on historic photography this riveting pattern seems to have been the norm. The last suggestion of the object being higher is also not possible. Anything higher would have interfered with the boiler barrel. This suggestion arose due to the curvature on the strap of rivets.

Close examination reveals that the seam of Artifact 133-007 contains original curvature. This curvature marks the transition point where one of the water legs begins to curve under the boiler. Figure 182, displays Artifacts 133-011 and 133-007 in their original context. A final comment on Artifact 133-007 relates to a bar-like strap that is mounted near the flange with three bolts and underlying washers. One of the recovered man holes, still retained a portion of boiler plating (Artifact 119-019). Mounted to that plate, was a similar bar-like strap (Figure 143). A considerable amount of this strap material was recovered from the wreck site. These straps were intended to hold the boiler in place. They would have secured both boilers together and to the inner hull of the ship. An identical example can be seen on the steamboat *Ticonderoga* (Figure 183). The only difference is that on *Ticonderoga*, the strap material joined to the boilers horizontally. Based on Artifact 133-007, *Westfield* used this strap in a diagonal fashion. The straps would have crossed between the two boilers, likely at several locations, creating an "X". Artifact 118-002 may be an example of these crossed securing straps from between the boilers (Figure 184). The artifact is constructed of the same thickness and width. Several broken bolts through the metal show how the artifact was once secured.

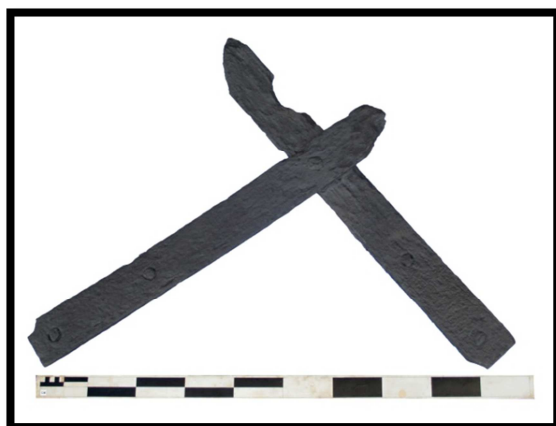
FIGURE 184. WROUGHT IRON BOILER SECURING STRAPS FROM *WESTFIELD* (ARTIFACT 118-002; SCALE CM/DM)

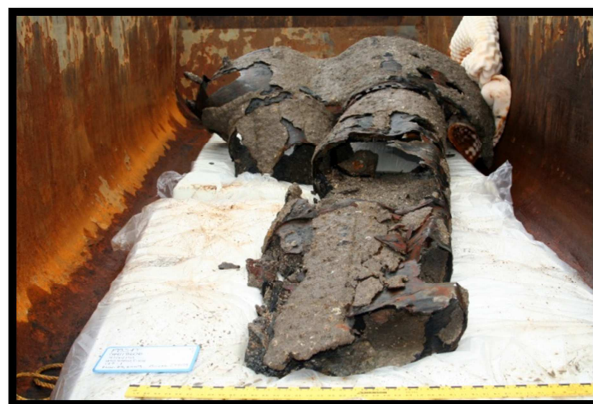
FIGURE 185. *WESTFIELD*'S BOILER FLUES (ARTIFACT 122-001; SCALE INCHES)

A massive section of the lower flues survived from inside the boiler barrel. Artifact 122-001 consists of two flues and the lower base section of the rear combustion chamber (Figure 185). Combined, the artifact measures 10.1 x 6.0 x 3.0 ft. The flues were built of wrought iron sheets, folded over, and riveted into tubular sections. Each section was then riveted to the next, to create the overall flue. Inside, each flue has a diameter of 1¾ ft. Both flues join onto a plate that has been carefully formed outwards and then tucked inside the base of the combustion chamber. The unique folds on this plate make the transition of the metal appear almost organic. This same fluid design stands out on Artifact 133-014, although on a much smaller scale (Figure 186). This artifact appears to have served the same function and likely came from slightly higher up on the combustion chamber (Figure 187). While considerably distorted, enough of the original curve remains to determine that the artifact once held a flue with an internal diameter somewhere between 10-14 inches.

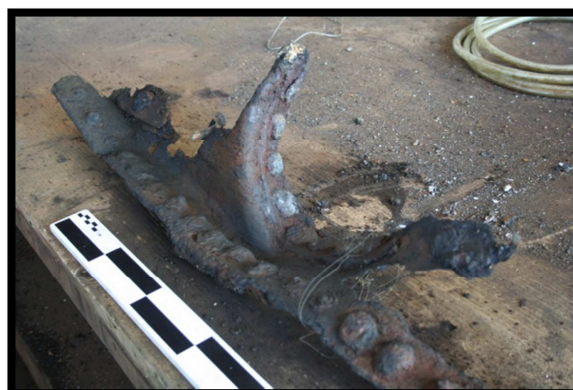
FIGURE 186. PLATING DESIGNED TO HOLD SMALLER ROUND FLUE (ARTIFACT 133-014; SCALE CM/DM)

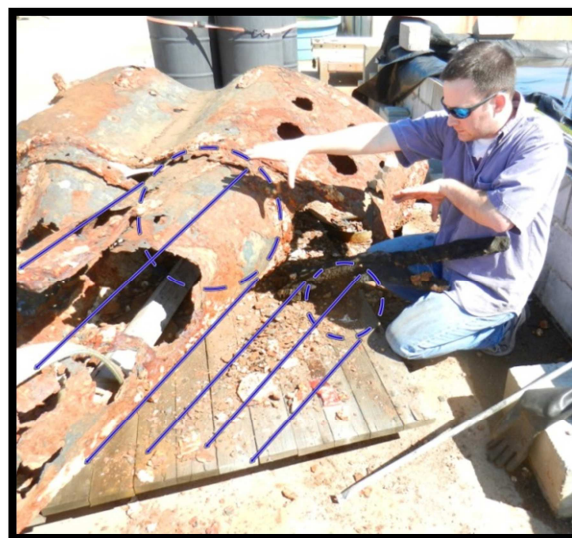
FIGURE 187. BOILER FLUES (ARTIFACT 133-014) IN CONTEXT

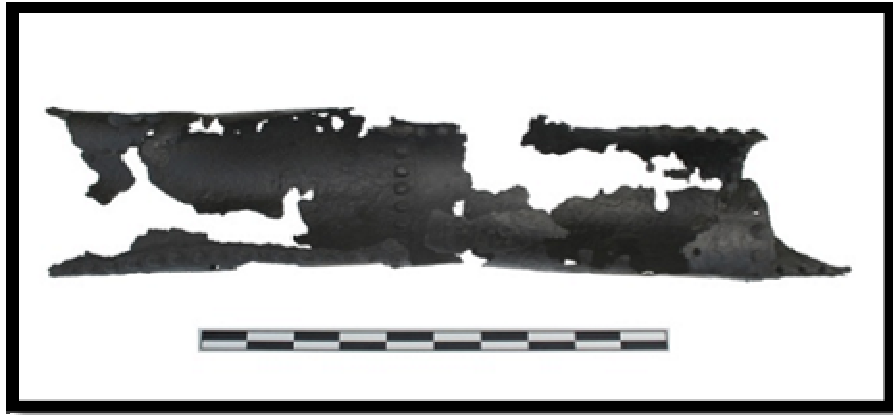
FIGURE 188. SMALLER UPPER SIDE FLUE ON *WESTFIELD* (ARTIFACT 121-010; SCALE DM)

One smaller separated flue was recovered (Figure 188). Artifact 121-010 consists of two pipe segments with an internal diameter of approximately 1 ft. Although smaller, the construction is identical to the larger flues. These artifacts suggest that in addition to the two main flues that left the firebox and joined the combustion chamber, additional smaller flues followed that same path.

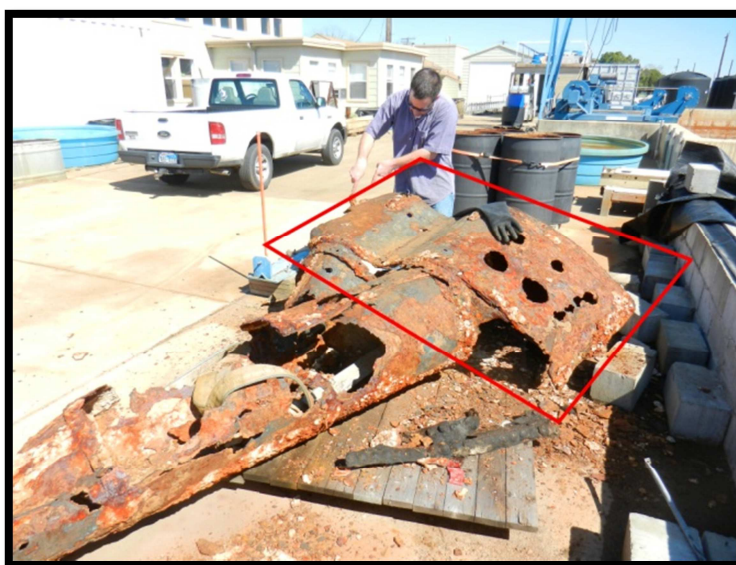
FIGURE 190. REMAINS OF LOWER COMBUSTION CHAMBER (ARTIFACT IS UPSIDE DOWN)

The surviving portion of *Westfield's* combustion chamber measured 2.2-x-6.0-x-3.0-ft (Figure 190). The base of the chamber was secured to the outer boiler barrel with several types of fasteners. Most of the underside, but not the direct bottom, used threaded staybolts. Many of the bolts were also found on the back wall. All of these bolts are heavily corroded, with only a few of them displaying their original threads. The more preserved examples show that after placement, the bolts were hammered over on both sides into conical rivets. The spacing appears similar to staybolts on the firebox, but this cannot be confirmed. The plating where most staybolts were positioned has corroded away. Of the staybolts that remain, they are too far from each other to determine a definitive spacing pattern. Several examples of these bolts were found separately from the combustion chamber and are in considerably better condition. These bolts were conserved as representative examples (Figure 191). At the very bottom of the chamber, the remnants of two double-ended crow's feet indicate, that like the firebox, the iron workers did not trust placing a heavy load onto staybolts. Staybolts were utilized inside compartments, but whenever a direct load required support, double-ended crow's feet were the fastener of choice.

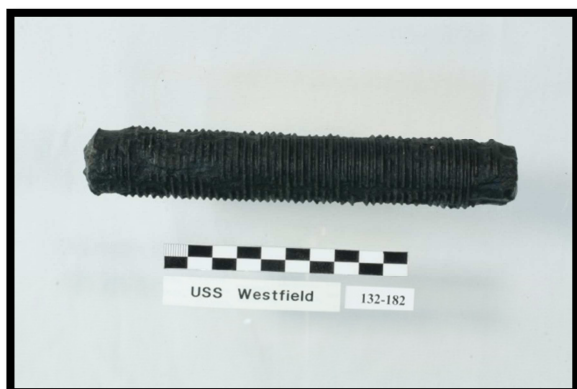
FIGURE 191. THREADED STAYBOLT WITH HAMMERED ENDS (ARTIFACT 132-182)

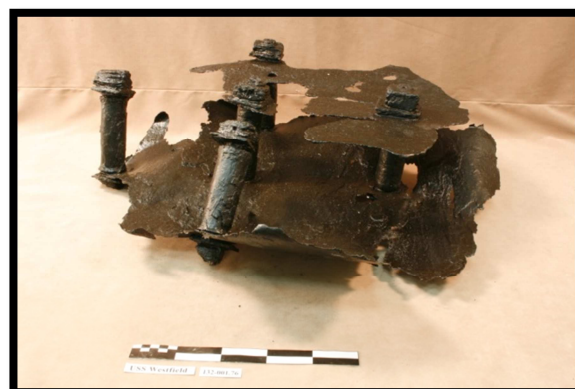
FIGURE 192. UPPER FRAGMENT OF COMBUSTION CHAMBER (ARTIFACT 132-001.76; SCALE CM)

One section from higher up on the combustion chamber was recovered separately (Figure 192). Artifact 132-001.76 consists of plate fragments from both the outer water jacket and the inner combustion chamber. Heavy staybolts secured these plates together. These staybolts are considerably larger and more robust than those found on the firebox. After the bolt passed through the plates and the central sleeve, a large threaded square nut was screwed down over a washer. This was common design found on other boilers (Figure 193). Although unclear, the heavy-duty

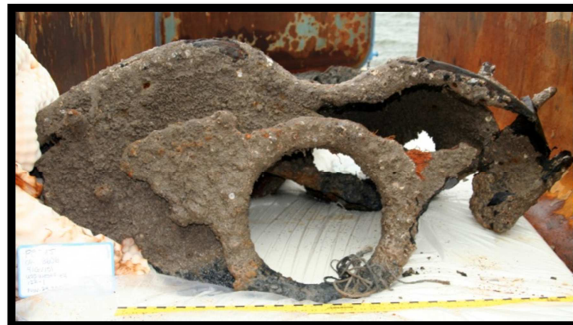
FIGURE 196. REAR ACCESS HATCH TO COMBUSTION CHAMBER (SCALE INCHES)

In order to clean the interior of the combustion chamber, a large access port was situated on the lower rear wall (Figure 196). This circular opening survived intact, and the diameter measures 16.0 inches. A single circular door (Artifact 120-009) was recovered and is believed to have originated from this location (Figure 197). The door has a diameter of 22 inches. The construction of the door matches that found on the fire doors. A front and rear plate are joined together with four small staybolts to maintain an even space between them. A single hinge runs across the door's outside plate diameter, before breaking off just past the edge. Like the fire doors, this round door closed against the outside of the boiler, rather than being seated in an internal frame. A similar example of this door can be seen in a historic photo of the steamer *Mary Powell* (Figure 198).

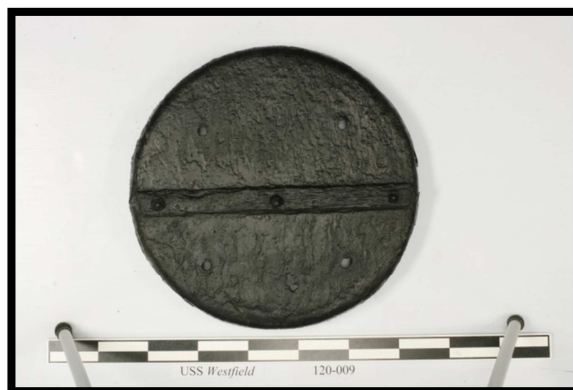
FIGURE 197. DOOR FROM HATCH ON REAR COMBUSTION CHAMBER (ARTIFACT 120-009; SCALE DM)

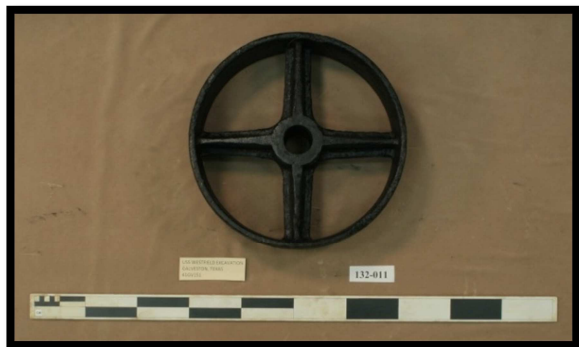
FIGURE 199. CAST IRON WHEEL FROM DONKEY ENGINE (ARTIFACT 132-011; SCALE CM/DM)

Four remaining artifacts fall into a miscellaneous category; however, all are believed to have been associated with the boiler room. Artifact 132-011 consists of a single cast iron wheel (Figure 199). The wheel contains four reinforced spokes that radiate out from a central shaft. Two small holes are placed within this shaft, along the interior walls. These holes were likely used for a key that held an axle in place. This wheel is believed to have come from a small engine. *Westfield's* boiler system

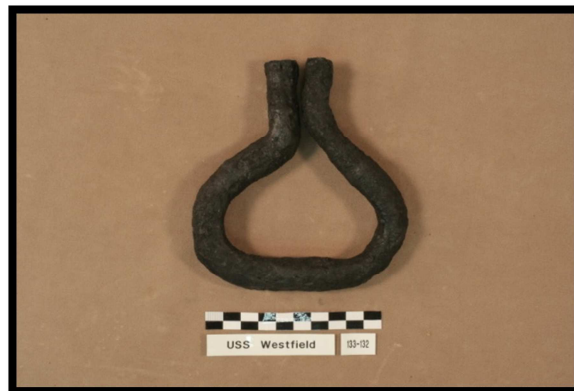
FIGURE 201. COAL STOKER HANDLE (ARTIFACT 133-132)

A second artifact (133-132) was likely a stoker handle used to tend the fires within the furnaces (Figure 201). Commonly, four types of stoker tools were used (Figure 202). The "slice" bar broke up the fire's thick surface crust when using bituminous coal. Anthracite coal burned considerably more efficiently, and did not tend to clump together. Generally, only the cinders needed occasional breaking. The similar "T" bar tool achieved this. A "hoe" bar was used to level the fire and clean out the lower ash pits. Finally, the "poker" bar reached in between the gratings and allowed the fireman to clean any ash or broken bit of coal out from within the slots.

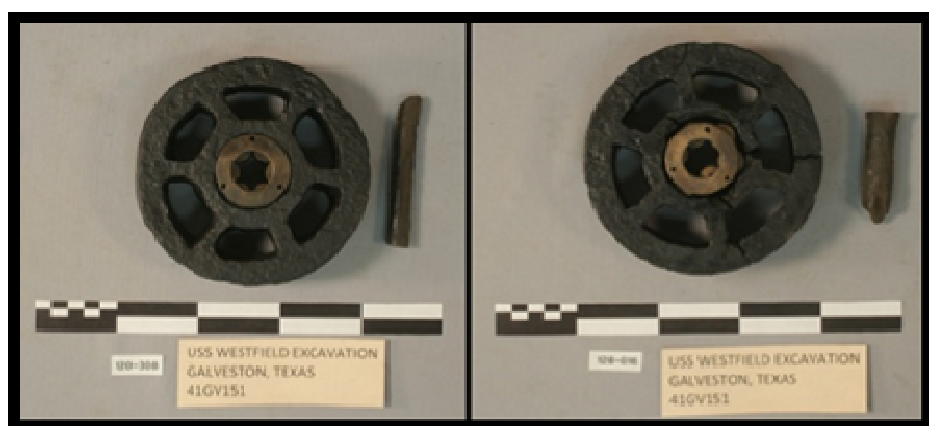
FIGURE 203. CAST IRON SHEAVES WITH BRASS BEARINGS (ARTIFACTS 120-308 AND 128-016)

The two final artifacts (120-308 and 128-016) are both relatively identical, consisting of a sheave and pin (Figure 203). Individually, each sheave is made up of a cast iron wheel that utilizes internal brass bearings. Within the bearings both artifacts had a remnant of a wrought iron pin. The edges of the wheel are recessed to carry a cable or chain. Normally, a block or sheave during this period was made of wood. These artifacts seem like they were intended to carry an extremely heavy load. Although the use of these artifacts has not been conclusively identified, there is a possibility that they were used to haul heavy loads of coal. One theory suggests that they may have been positioned on each side of the boiler to allow for the quick transport and refilling of the coal bunkers.

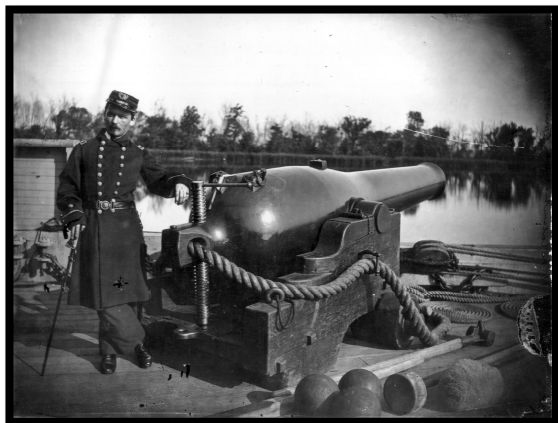
FIGURE 204: HISTORIC IMAGE OF A DAHLGREN 9-INCH CANNON. COURTESY OF THE NATIONAL ARCHIVES, FROM THE MATHEW BRADY CIVIL WAR PHOTOS COLLECTION.

Several artifacts recovered from the site in the vicinity of the cannon have been identified as parts of a gun carriage or associated tackle. Details from the Brady Collection photograph shown in Figure 204 are enlarged in Figure 212 to illustrate the function of various artifacts recovered from the site including: a rear gun sight (figures 213 and 214; compare Figure 212-A); a firing hammer and hammer cord (figures 215, 216 and 217; compare Figure 212-B); a fragment of an elevation screw (Figure 218; compare Figure 212-C); and a cascabel block, attached when recovered, used to secure the breach rope (figures 219 and 220; compare Figure 212-D).
